MO NONAME 408 LAKE DAM

OSAGE COUNTY, MISSOURI

**PHASE 1 INSPECTION REPORT  
NATIONAL DAM SAFETY PROGRAM**

PREPARED BY: HOSKINS-WESTERN-SONDEREGGER, INC.

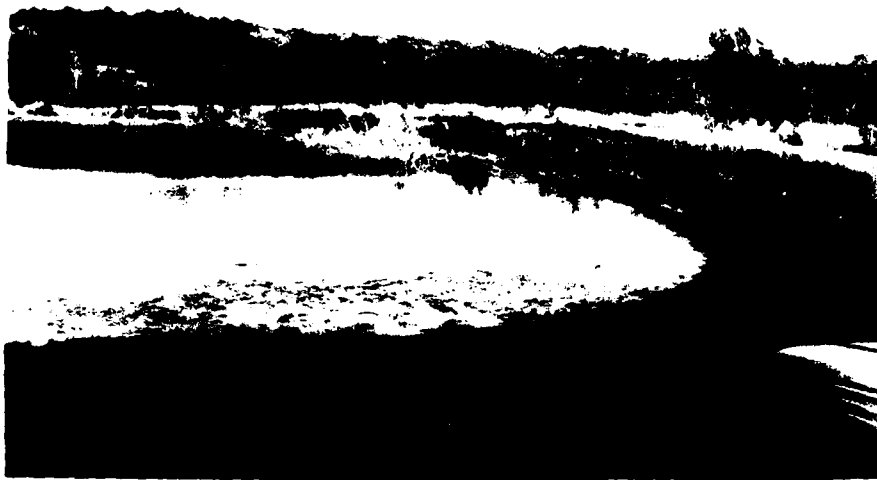
PHOTO NO. 2  
LOOKING EAST  
FROM SOUTHEAST  
CORNER OF LAKE

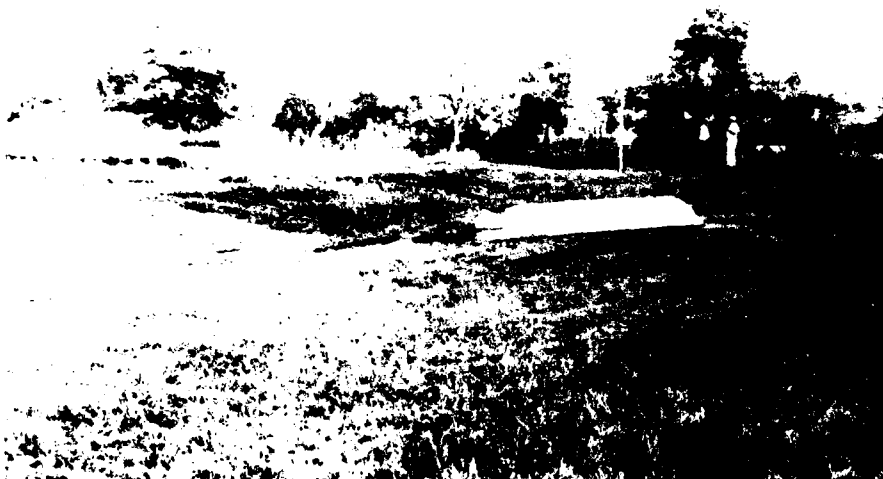
PHOTO NO. 3  
LOOKING DOWNSTREAM  
IN PRIMARY SPILLWAY  
ON RIGHT ABUTMENT.  
ROD ON CONTROL SECTION  
AT CENTERLINE OF DAM.

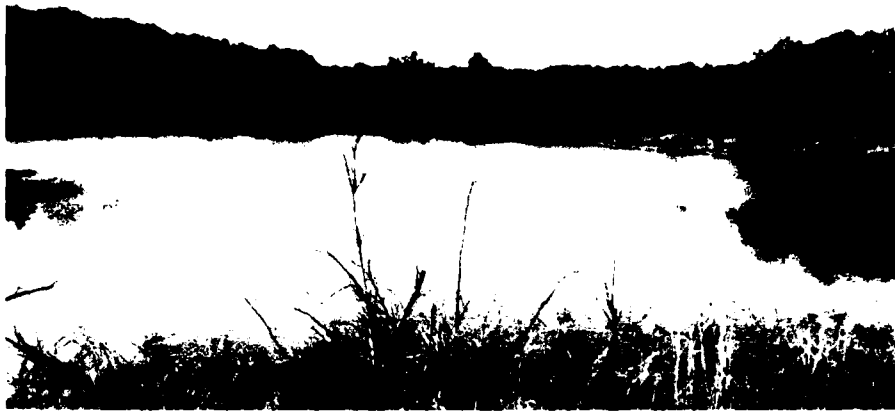
PHOTO NO. 5  
LOOKING UPSTREAM FROM  
CENTERLINE STATION 4+00±

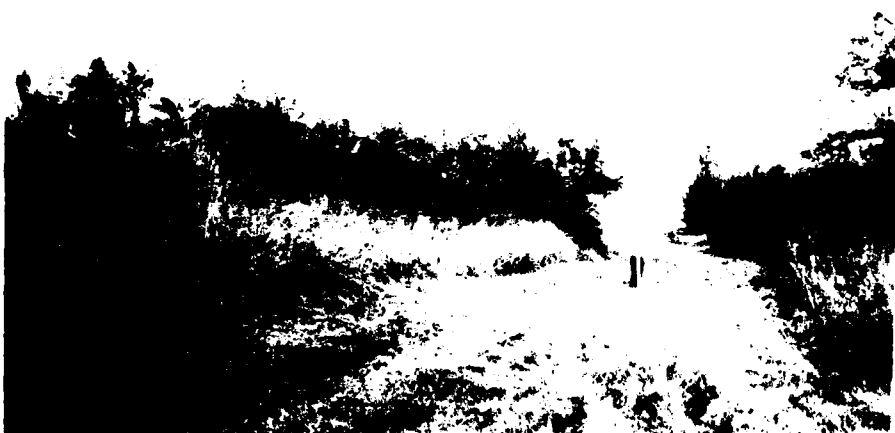
PHOTO NO. 6  
LOOKING DOWNSTREAM  
IN RIGHT EMERGENCY  
SPILLWAY EXIT CHANNEL
